July 8, 2020

Our Reference: 32294

**Reference: City of Greenwood Fire Hall – Structural Review Memorandum**

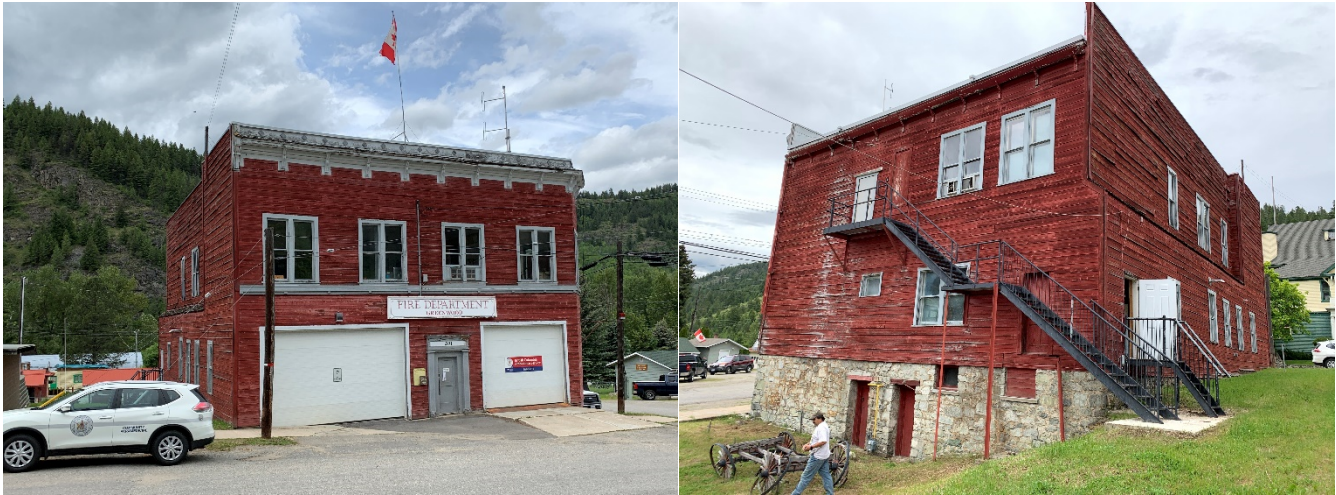
The building is located at 201 S Government Street, Greenwood, BC. It is a three-story building including a partial basement. Due to the slope of the site, access to the front of the building along South Government Street (East side) is at main floor level and the rear of the building (West side) is accessed at basement level. There is a steel fire escape structure at the rear of the building allowing exit from the second floor of the building.

Photo 1: Front and rear of the building

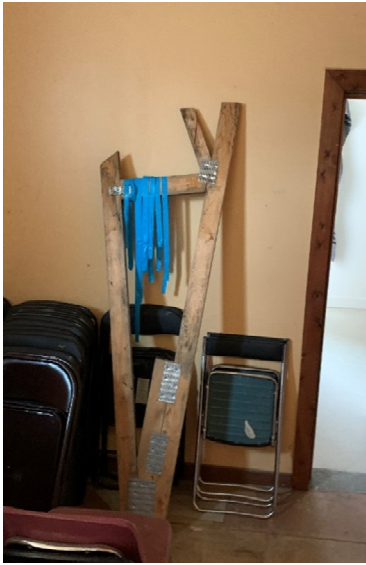
The roof structure was not reviewed during this site visit, however, a cut piece of roof truss was noted in a storage room on the main floor of the building.

Photo 2: Cut roof truss on main floor

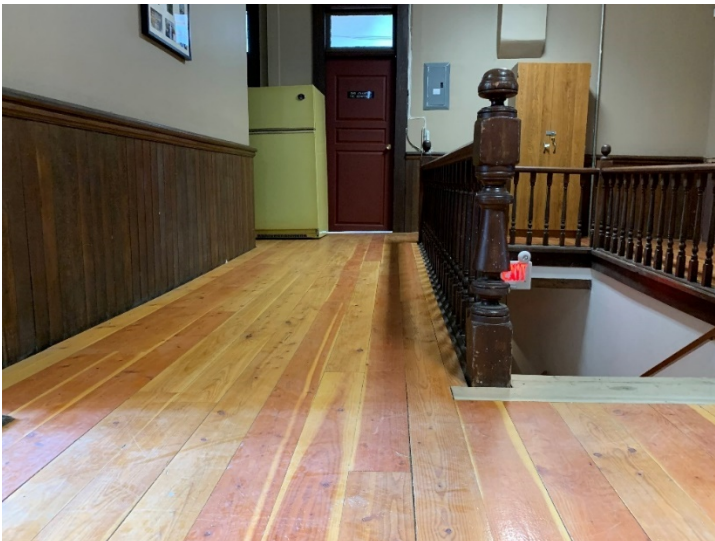
The second floor is mixed use and comprises of offices, a meeting room, storage and a room currently being renovated to provide accommodation for a firefighter. It was noted that the second floor is generally uneven, with varying height gaps between the floor and doors. This unevenness was especially evident in the room being prepared for the firefighter accomodation.

A metal fire escape is present to the rear of the building and is constructed from steel HSS, channel and angle members in a series of stairs and landings. The connection of the steel structure to the building and foundation is unknown.

Photo 3: Stair access and flooring at second floor

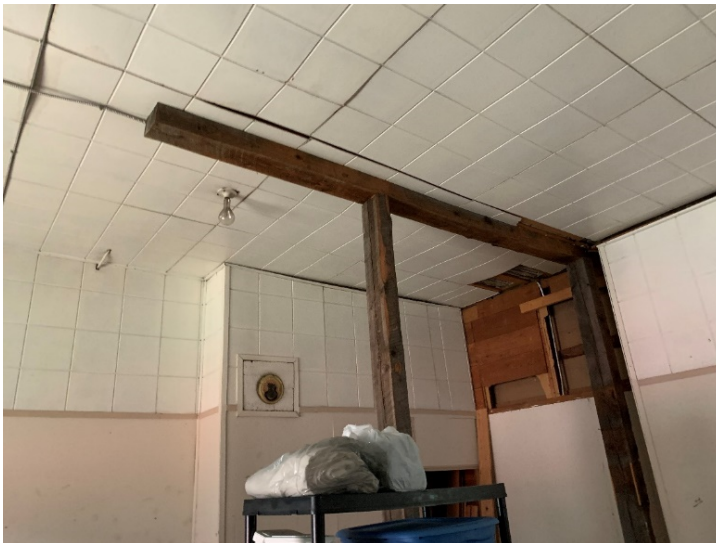
There are storage rooms to the rear of the building and these areas also have exposed post and beam structures installed indicated a modification and shoring at some point in the past. The storage room adjacent the fire truck had a timber post and beam installed and the ceiling deflections was evident in the ceiling tiles. The storage room behind the ambulance also had two sets of posts and beams installed to support the floor above. In all cases the posts bear onto timber lagging to spread the column point loads onto the main floor system.

Photo 4: Post and beam propping with floor deflection evident in ceiling tiles

- It appears shoring posts and beams have been introduced into the building in response to bearing walls being removed or to reduce floor sag. It is unknown if these members were designed and whether these revised load paths continue through the building to a foundation or terminated onto the main floor.

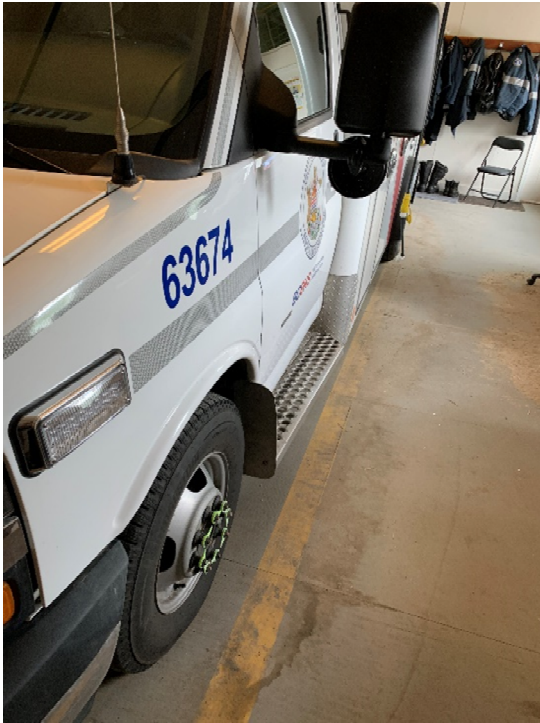
The ambulance vehicle is parked within the building on a timber suspended floor. A hatch in the main floor allowed access to a crawlspace. The main floor under the ambulance appeared to be comprised of plywood sheathing over timber joists over timber beams and posts. It appeared that some of the posts bear directly onto rock. It is unknown if this floor is designed for the ambulance GVWR of ~5.9 Tonnes. Water staining was evident on the floor sheathing around the footprint of the ambulance likely from parking the vehicle when wet.

Photo 5: Water staining on sheathing around the ambulance

- The introduction of the fire truck and ambulance has created large live loading for the building. The ambulance currently bears onto a suspended timber floor and the fire truck bears onto a slab on grade which may apply an additional lateral pressure to the stone built retaining wall.

- The vehicles are removed and rehoused in code compliant buildings.
- Occupancy of the building is kept to a minimum and limited to essential staff only. The building should not be used as a place of shelter.

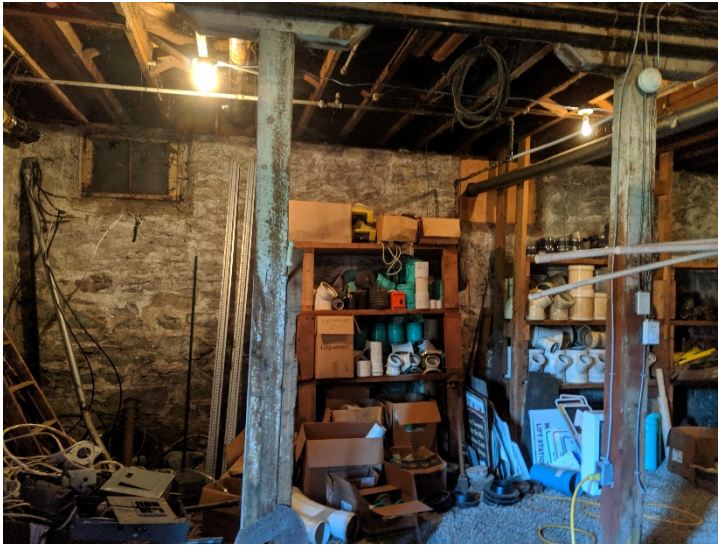
The perimeter foundations to the building appear to be constructed of pointed stone walls. From this initial building review, there appear to be three different basement/foundation conditions:

The stone foundation wall between the west and east side of the building is a retaining wall. This wall is currently retaining the ground and the live load of the fire truck and partial ambulance loading.

Photo 6: Basement at west side
